Manhole Inspection Summary

Manhole # S27S__009MH

Insp Date: **4/25/08 11:38 AM**

Location Address: **1620 Bush st**

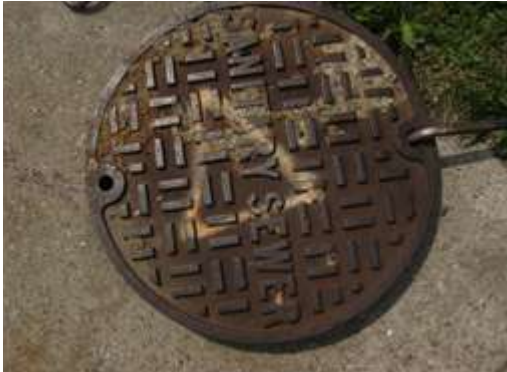
Cover View

Cover Shape: **Circular** Diameter: **25.** (in.) Length: **0** (in.) Dist A/B Grade: **0** (in.)
5

Type: **Sanitary** Condition: **Sound** Cover Material: **Cast Iron**

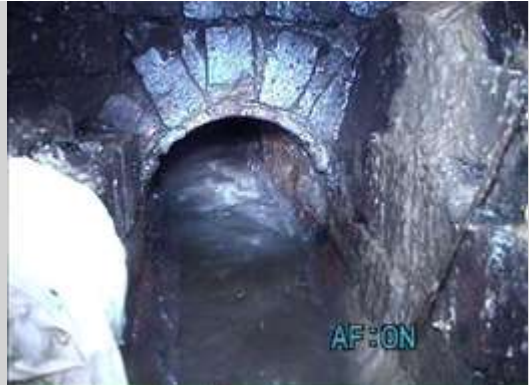
12 O'Clock Outflow

10 in. Circular Gravity Sewer
Pipe Out @ 12 O'Clock

Pipe Height: **10.8** (in.) Rod and Bar (Angled)
Pipe Material: **Clay** ☐ Pipe Lined
Invert Depth: **14.00** (ft.) Flow Characteristics: **Fast**
Deposits: ☒ None ☐ Mud ☐ Sludge ☐ Debris ☐ Grease
Silt Depth: **0** (in.) Deposits Extent:
Infiltration: **None** Pipe Seal Cond: **Sound**

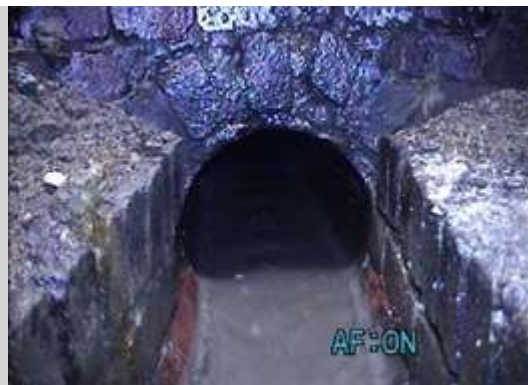
6 O'Clock Inflow

10 in. Circular Gravity Sewer
Pipe In @ 6 O'Clock

Pipe Height: **10.8** (in.) Rod and Bar (Angled)

Pipe Material: **Clay** ☐ Pipe Lined

Infiltration: **None** Pipe Seal Cond: **Sound**
